Manhole Inspection Summary

Manhole # S17GG1007MH

Location Address: **4000 GREENSPRING AVE**

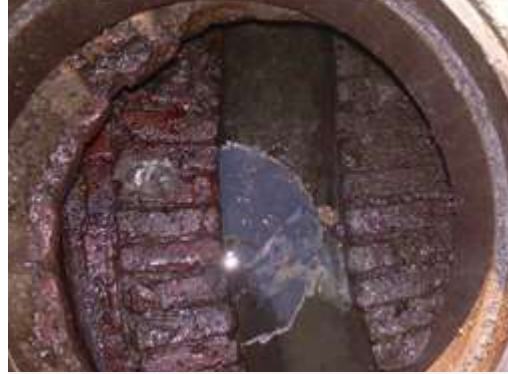
Top View

Frame offset. Evidence of surcharge - Bench debris. Channel debris.

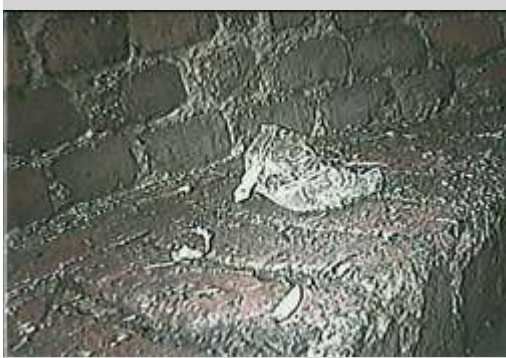
Evidence of surcharge

Bench debris.

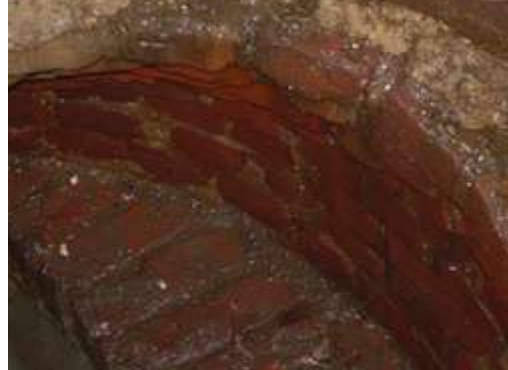
Defect 3

Frame leaks. Adjustment deterioration and infiltration.

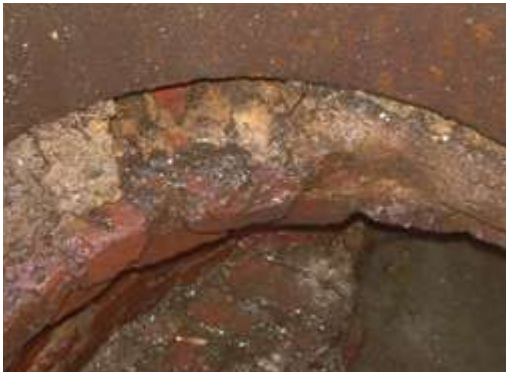
Defect

Frame leaks. Adjustment deterioration and infiltration - other side.

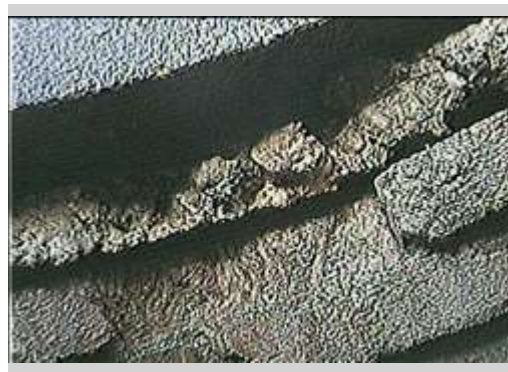
Defect

Adjustment deterioration and infiltration.

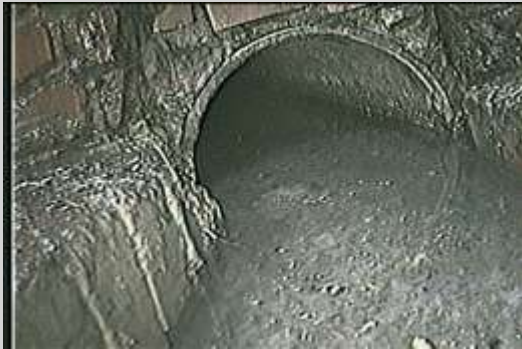
8 in. Circular Gravity Sewer Pipe Out @ 12 O'Clock

Deposits: ☐ None ☐ Mud ☐ Sludge ☒ **Debris** ☐ Grease

Silt Depth: **2** (in.) Deposits Extent: **Medium**

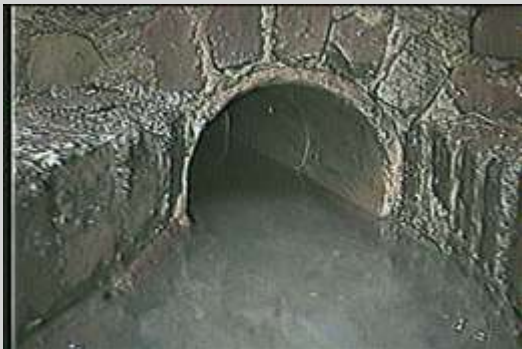
8 in. Circular Gravity Sewer Pipe In @ 5 O'Clock

Infiltration: **Evidence** Pipe Seal Cond: **Cracked**
